INDOOR AIR QUALITY ASSESSMENT

**German International School
54 Essex Street
Cambridge, MA**

Prepared by:
Massachusetts Department of Public Health
Center for Environmental Health
Emergency Response Indoor Air Quality Program
November 2005

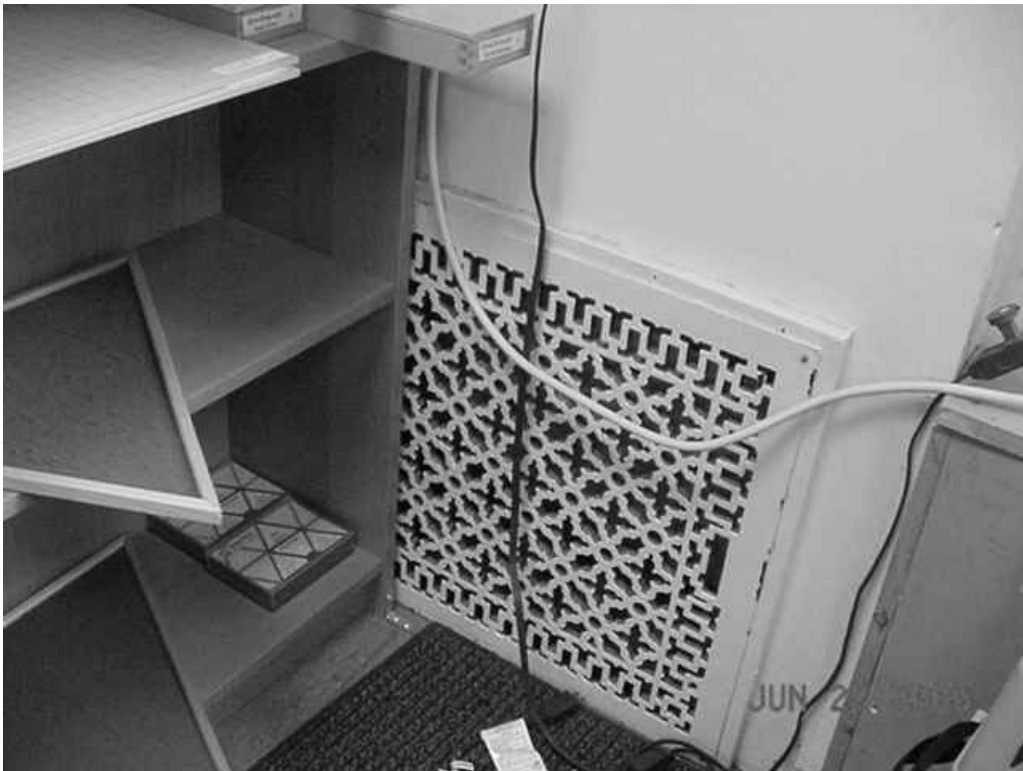
Picture 1

The GIS has no mechanical ventilation system, but relies solely on openable windows for air exchange. Ventilation was originally provided by a natural gravity ventilation system, which distributed rising heated air via a process known as the stack effect. This system has since been abandoned (Pictures 1 and 2). Therefore, the sole source of fresh air is openable windows.

Abandoned Vent for Natural Gravity Feed Ventilation System

1. Use openable windows to facilitate air exchange. Care should be taken to ensure windows are properly closed at night and weekends to avoid freezing of pipes and potential flooding.
2. For buildings in New England, periods of low relative humidity during the winter are often unavoidable. Therefore, scrupulous cleaning practices should be adopted to minimize common indoor air contaminants whose irritant effects can be enhanced when

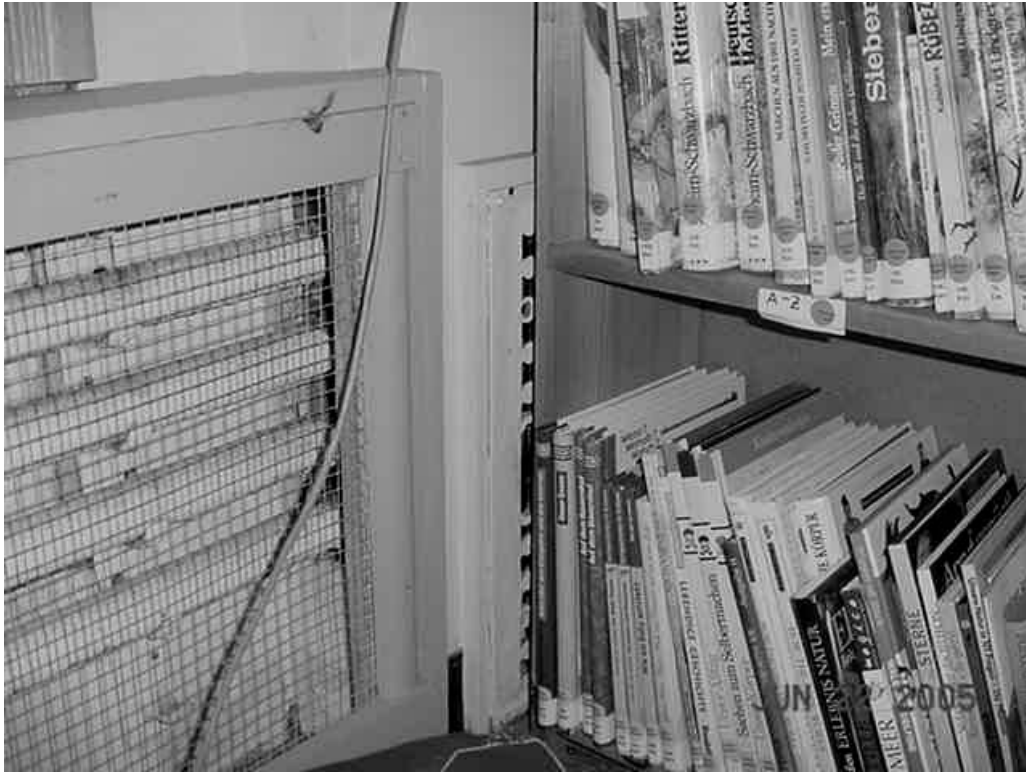
Picture 2

Abandoned Vent for Natural Gravity Feed Ventilation System

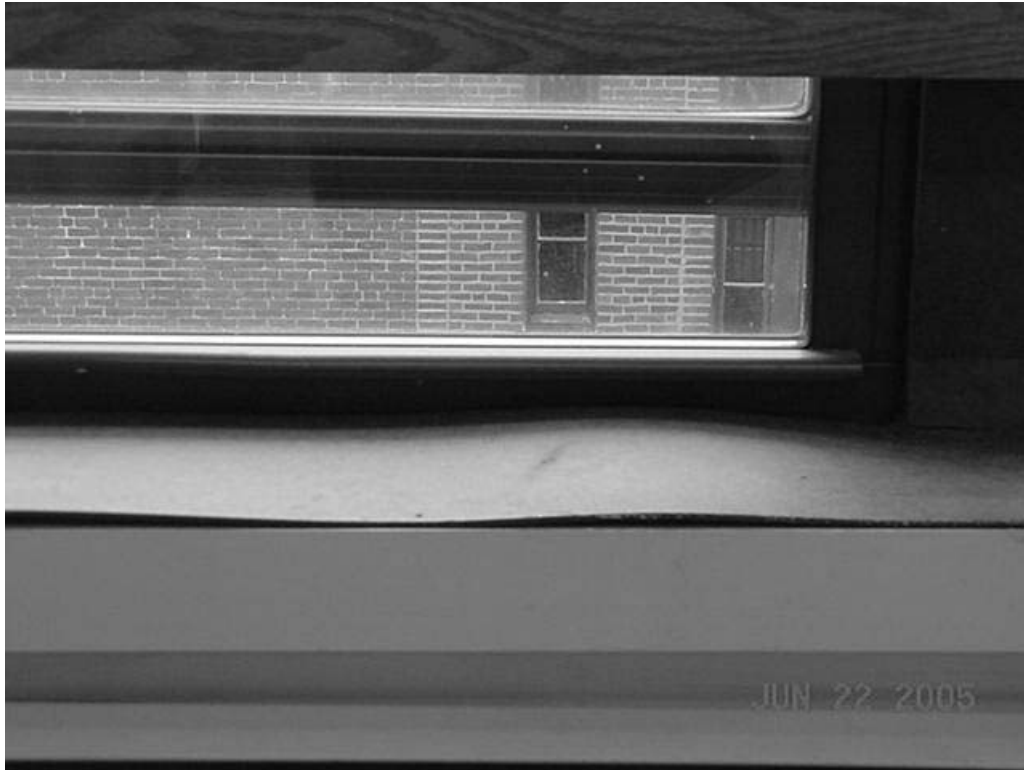
Picture 3

A few areas had water-stained ceiling tiles, which can indicate leaks from the roof or plumbing system. Occupants reported dripping pipes in the hallway. Water-damaged ceiling tiles can provide a source for mold and should be replaced after a water leak is discovered and repaired. A musty odor and water damage was noted on the windowsill in English Center A (Picture 3). These conditions can indicate a water infiltration problem with the window frame and/or window flashing.

Water Damaged/Warped Windowsill in English Center A

4. Make repairs to window frames to prevent drafts and water penetration.
 5. Clean and maintain aquariums to prevent mold/algal growth and associated odors.

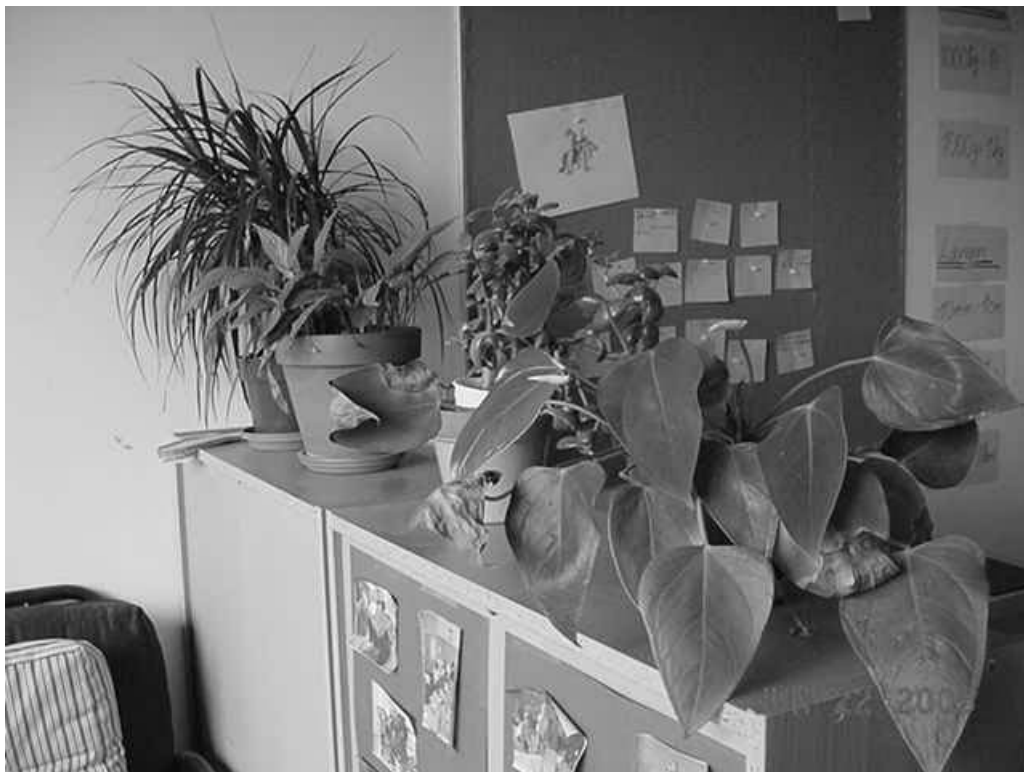
Picture 4

Plants were located in several classrooms (Picture 4). Plants can be a source of pollen and mold, which can be respiratory irritants for some individuals. Plants should be properly maintained and equipped with drip pans to prevent moistening and potential mold growth to porous building materials. A few areas had aquariums in classrooms. Aquariums should be properly maintained to prevent microbial/algae growth, which can emit unpleasant odors (Picture 5).

Plants in Classroom

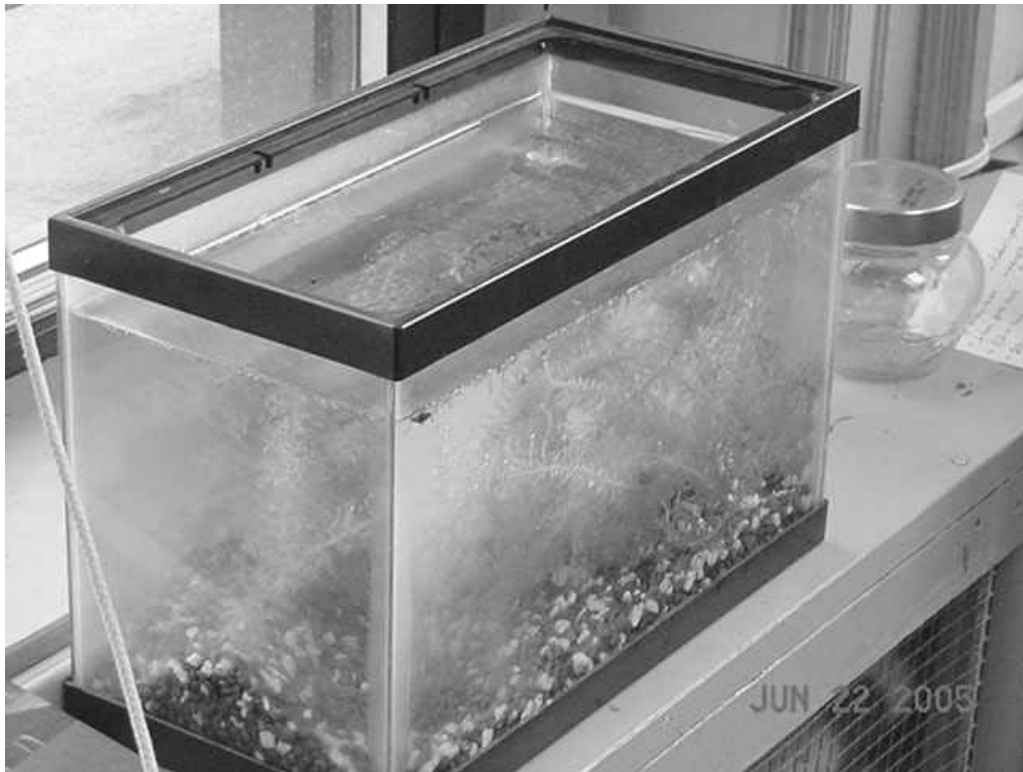
Picture 5

Aquarium in Classroom Green with Algal Growth

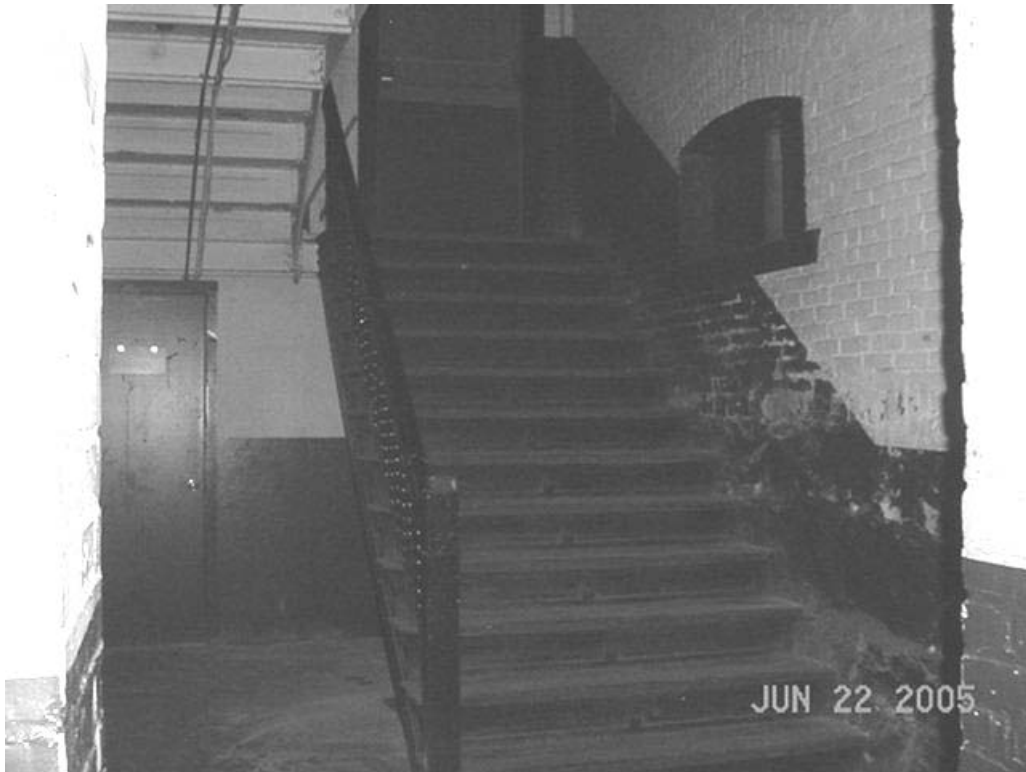
Picture 6

Boiler room odors were reported in several areas. Several pathways exist for boiler room odors and other pollutants to move from the boiler room into occupied areas. The boiler room is located in the basement of the building. The door to the stairwell leading down towards the boiler room (Pictures 6 and 7) had spaces beneath the door and light could be seen penetrating into the stairwell through this space. Another possible pathway for boiler room odors is through utility holes, such as those observed in the hallway (Picture 8). The ceiling/walls of the boiler room are penetrated by holes for utilities (e.g., electrical, plumbing). These holes can present potential pathways into occupied areas if they are not airtight. In order to explain how boiler room pollutants may be impacting adjacent areas, the following concepts concerning heated air and creation of air movement must be understood.

Stairwell from the Boiler Room to the First Floor

8. Store and label food appropriately. Refrain from re-using food and/or containers as project materials to prevent pest attraction.
 9. Ensure that the stairwell door to the boiler room is closed at all times.

10. Ensure that the stairwell door to the boiler room fits completely flush with the threshold. Seal door on all sides with foam tape, and/or weather-stripping. Consider installing weather-stripping/door sweeps on both sides of door to provide a dual barrier. Ensure tightness of door by monitoring for light penetration and drafts around the doorframe.

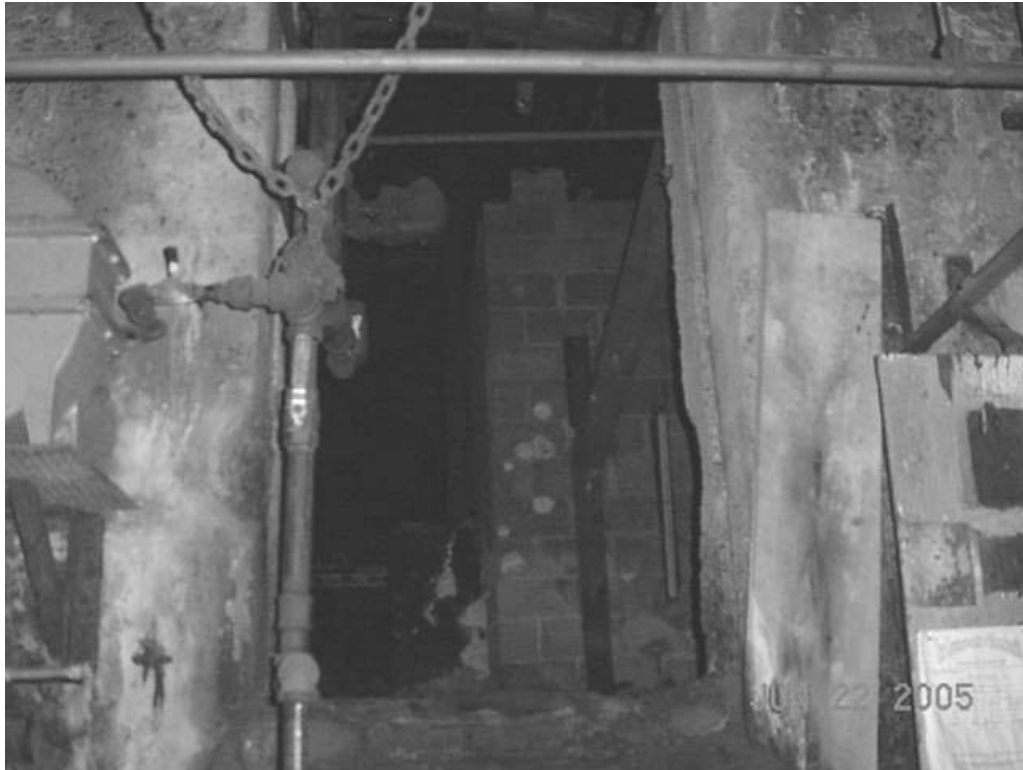
Picture 7

Boiler Room

11. Ensure all utility holes are properly sealed in both the boiler room and their terminus to eliminate pollutant paths of migration.
12. Relocate or consider reducing the amount of materials stored in classrooms to allow for more thorough cleaning. Clean items regularly with a wet cloth or sponge to prevent excessive dust build-up.

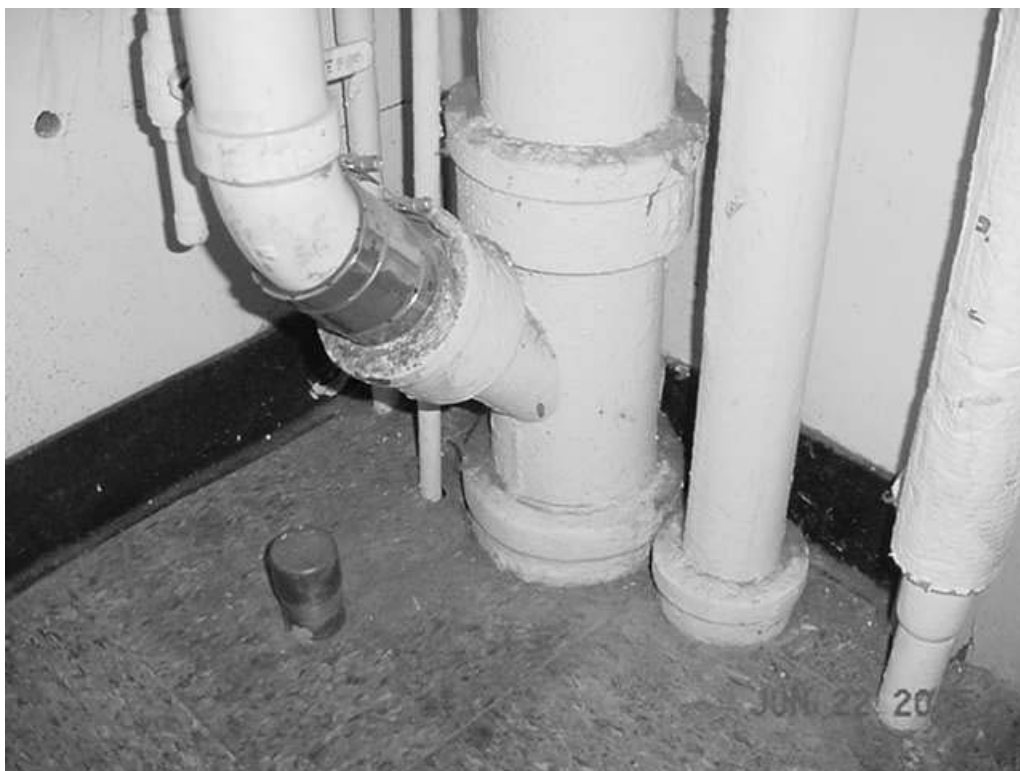
Picture 8

Leaking pipe and open utility holes

3. Ensure roof and/or plumbing leaks are repaired, and replace/repair water damaged building materials. Examine the area above and around these areas for mold growth. Disinfect areas of water leaks with an appropriate antimicrobial.

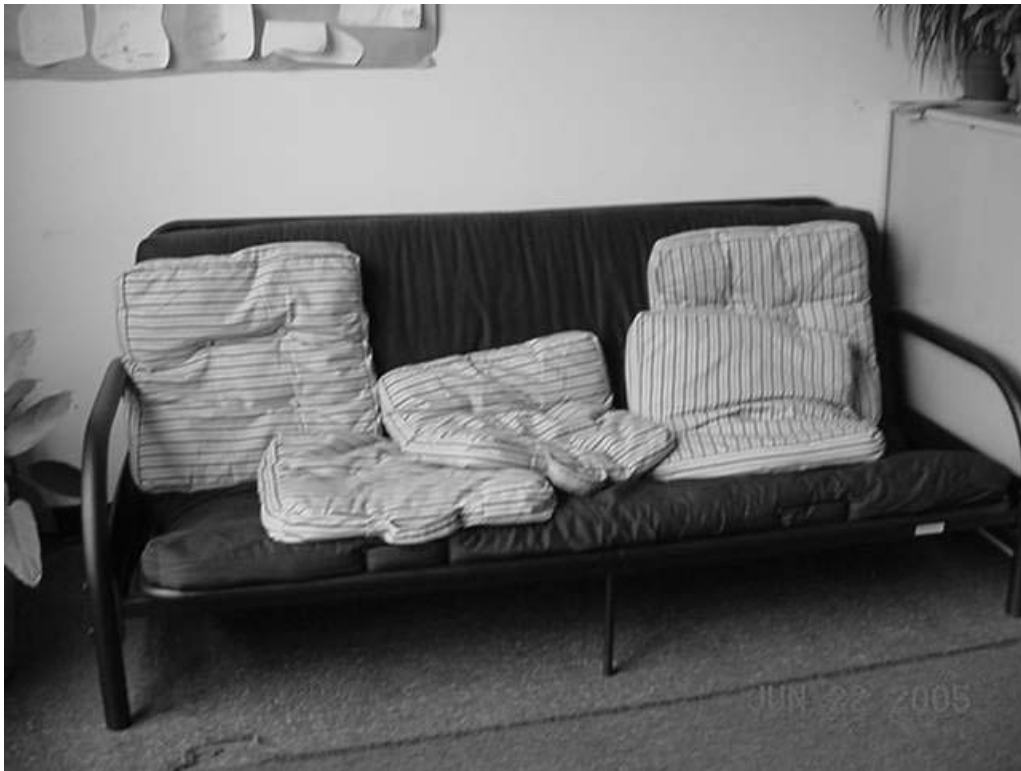
Picture 9

Finally, some classrooms contained upholstered furniture and pillows (Picture 9). Upholstered furniture is covered with fabric that encounters human skin. This type of contact

can leave oils, perspiration, hair and skin cells. Dust mites feed upon human skin cells and excrete waste products that contain allergens. In addition, if relative humidity levels increase above 60 percent (e.g., during spring/summer), dust mites tend to proliferate (US EPA, 1992). In order to remove dust mites and other pollutants, frequent vacuuming of upholstered furniture is recommended (Berry, 1994). It is also recommended that if upholstered furniture were present in schools, it should be professionally cleaned on an annual basis or every six months if dusty conditions exist outdoors (IICRC, 2000).

Upholstered Furniture and Pillows

13. Clean chalkboard/dry erase marker trays regularly to prevent the build-up of excessive chalk dust and particulates.
14. Clean upholstered furniture on the schedule recommended in this report. If not possible/practical, remove upholstered furniture from classrooms.
